ROTORUA
LAKES COUNCIL

TE WHARE TAONGA O TE ARAWA

Building Update

28 September 2022

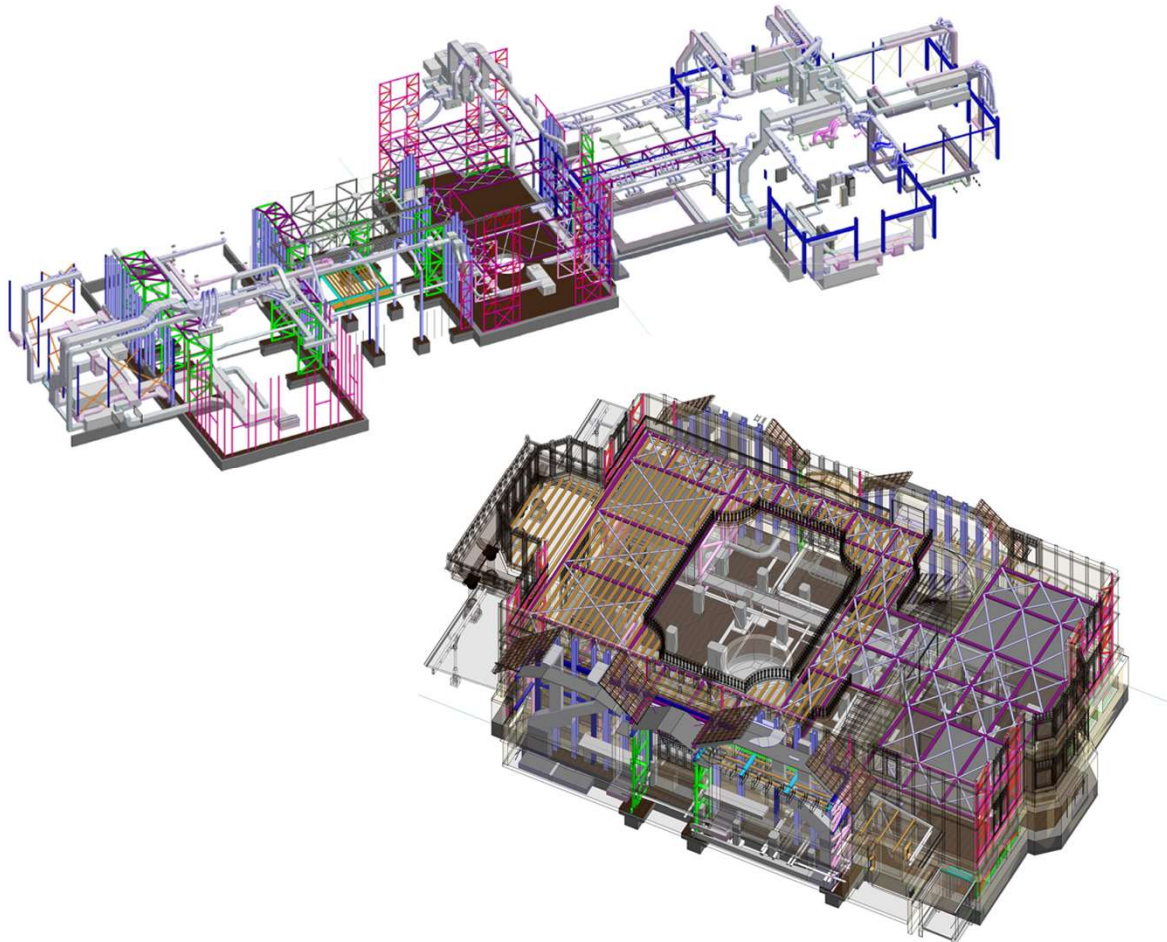
STRUCTURAL RE-DESIGN - FROM

Force based design

- Evasive intervention on heritage fabric
- Buildability risks
- High cost

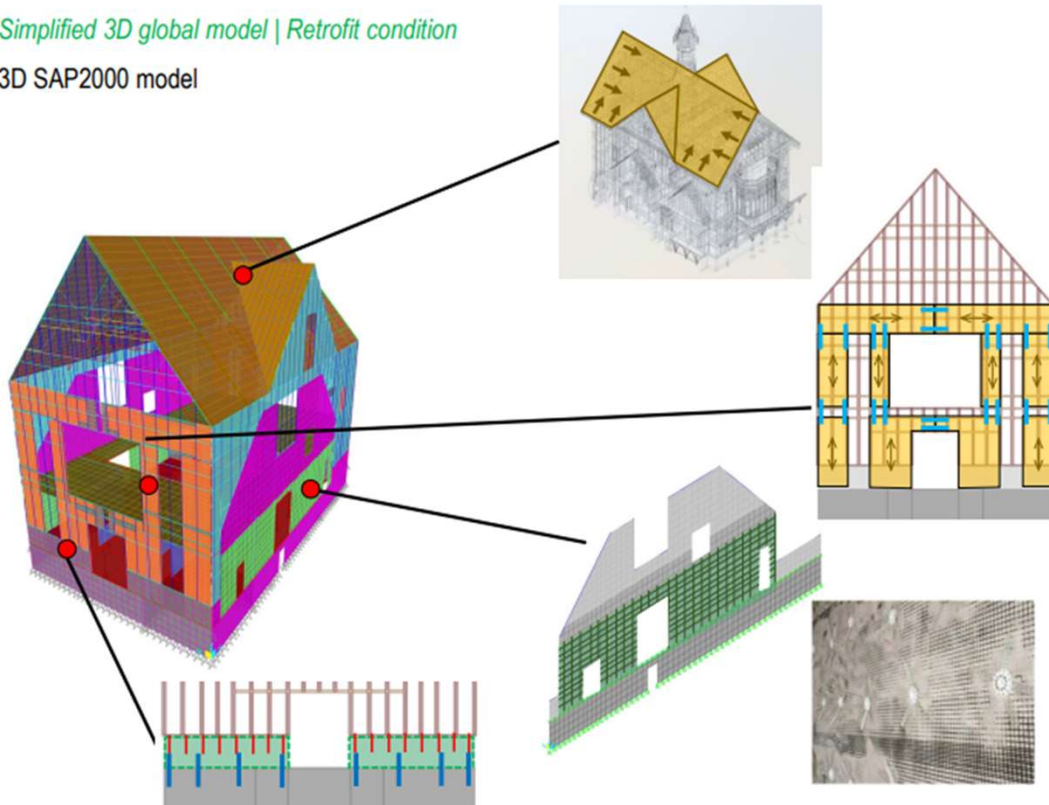
...TO RESET STRUCTURAL DESIGN

Simplified 3D global model | Retrofit condition

3D SAP2000 model

Displacement based design has met expectations:

- 80% NBS
- Buildable
- Less invasive
- Faster
- More cost effective

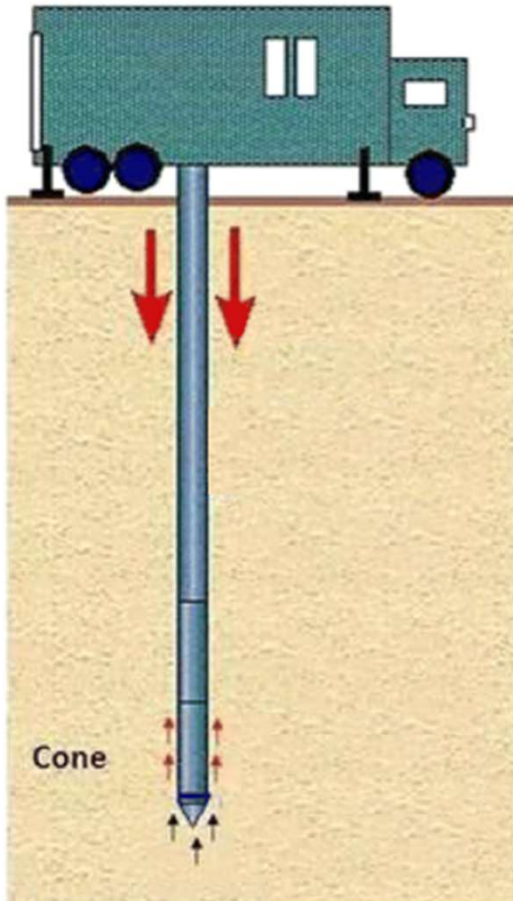
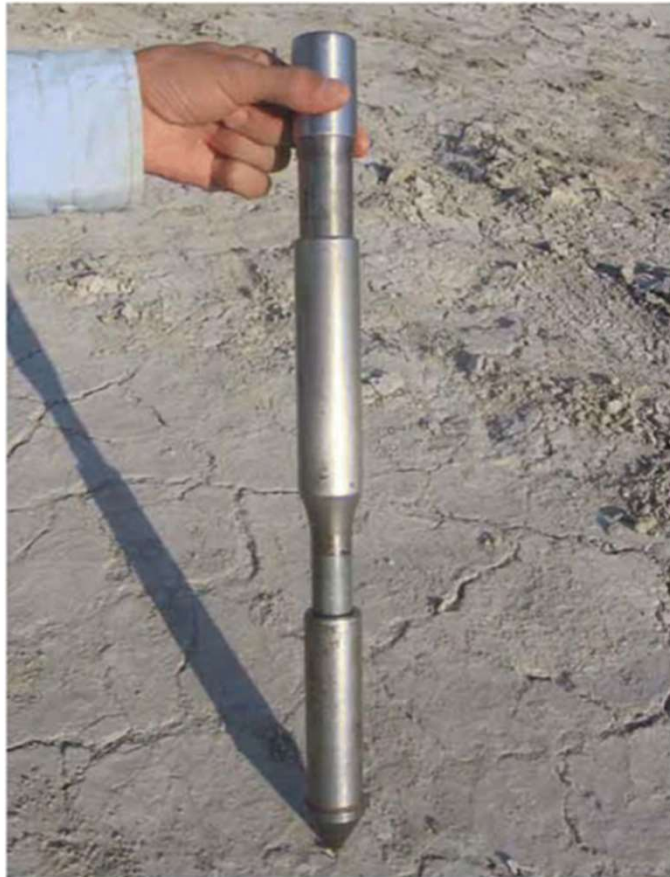
TRADITIONAL LIQUEFACTION TESTING

40% NBS

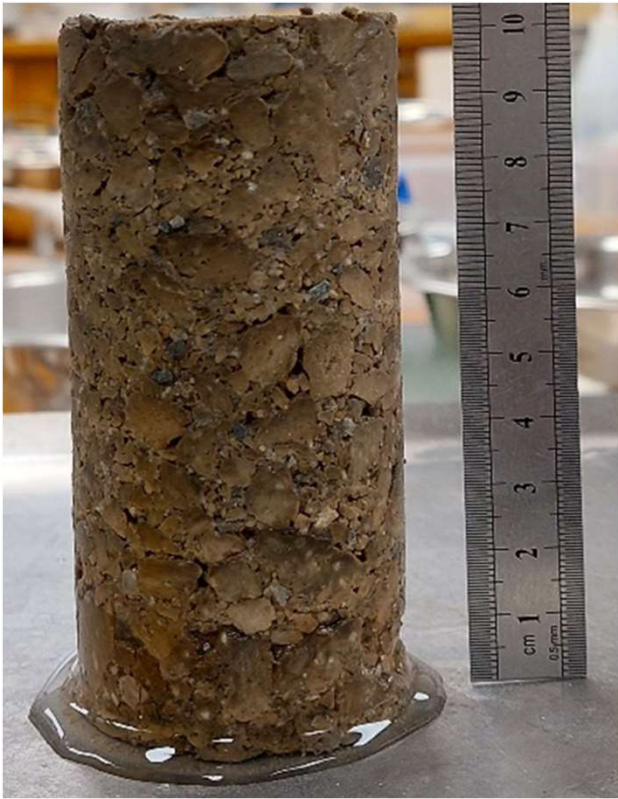
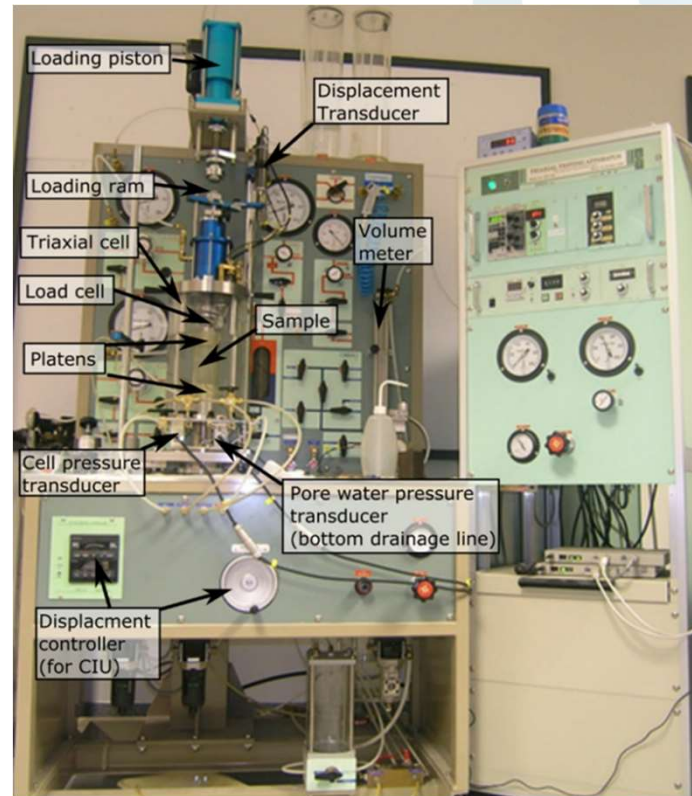
SPECIALIST TESTING

70% NBS

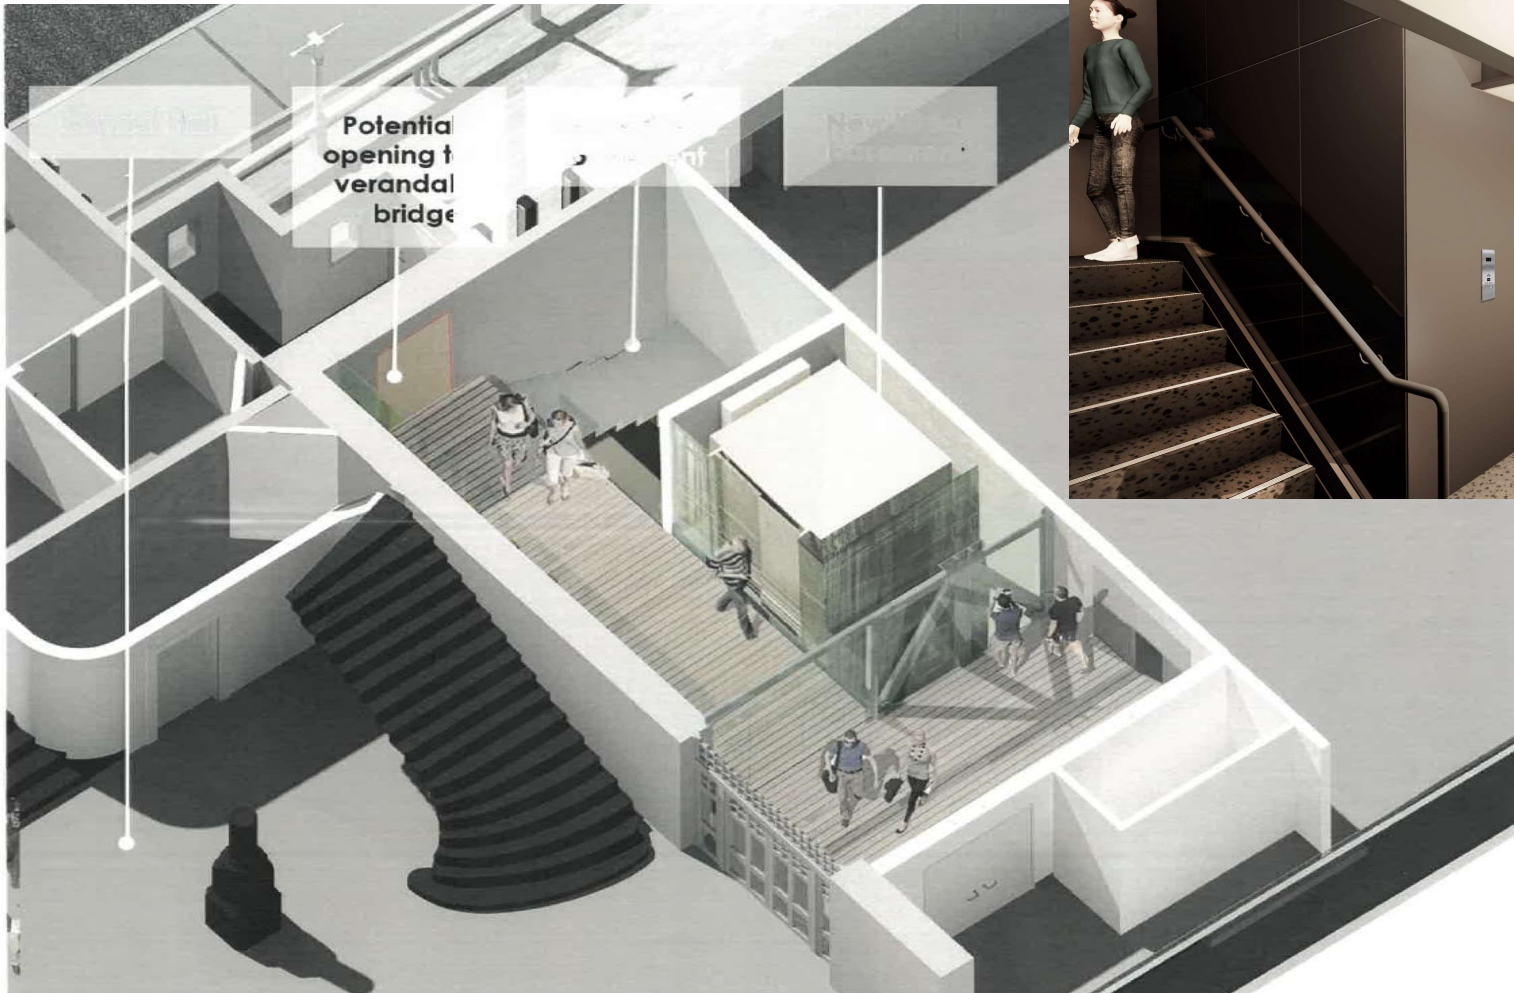
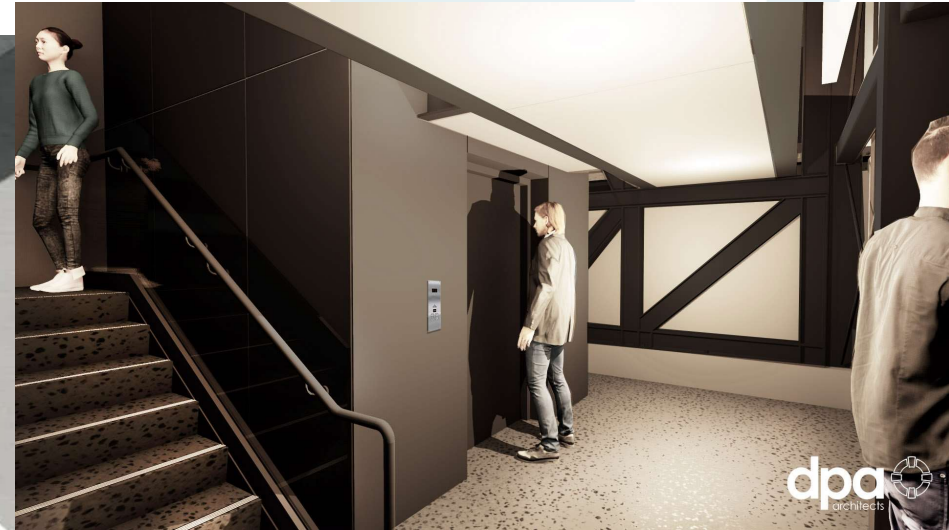
GROUND FLOOR NEW LIFT AND BASEMENT ACCESS

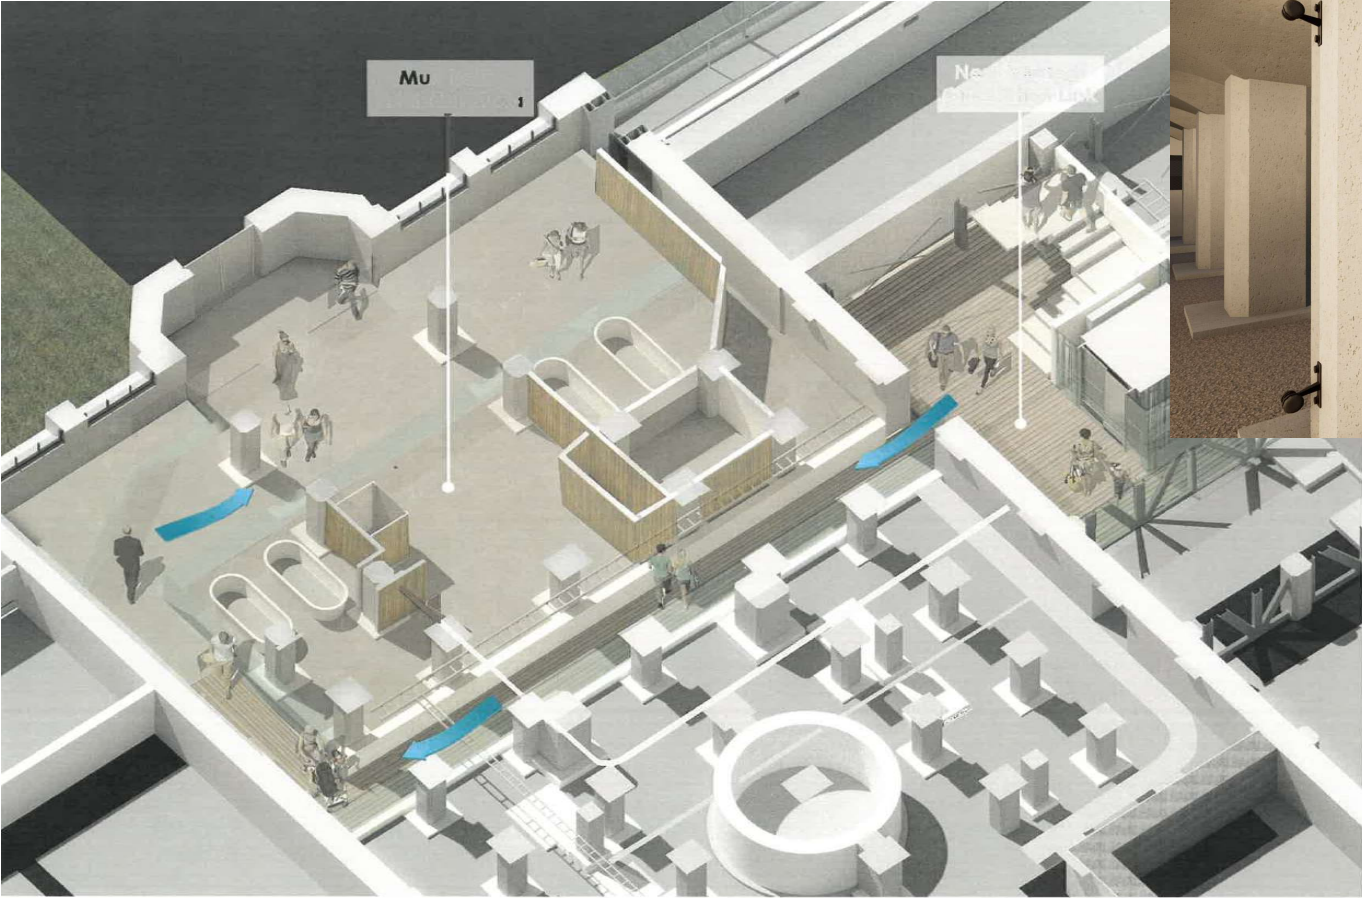
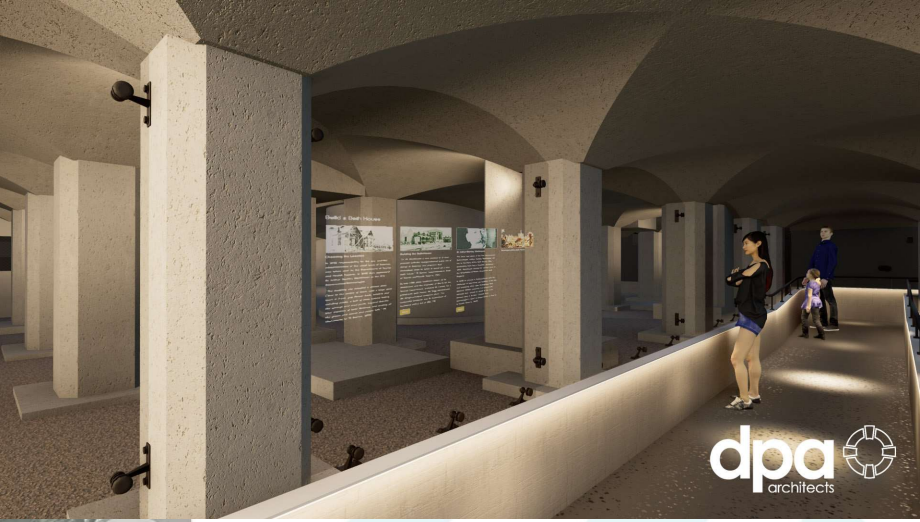
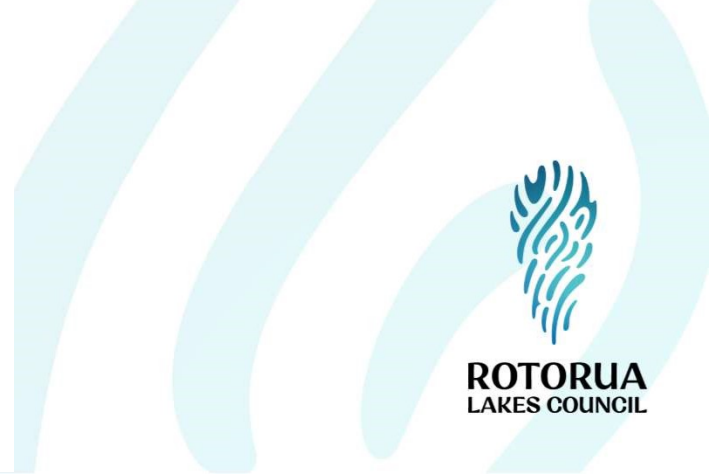
MUD BATH BASEMENT
